Hazardous Materials Special Investigation Report
Hazardous Materials Release, Missouri Pacific
Railroad Company's North Little Rock, Arkansas
Railroad Yard, December 31, 1984

(U.S.) National Transportation Safety Board
Washington, DC

**HAZARDOUS MATERIALS RELEASE
MISSOURI PACIFIC RAILROAD COMPANY'S
NORTH LITTLE ROCK, ARKANSAS
RAILROAD YARD
DECEMBER 31, 1984**

NTSB/SIR-85/03

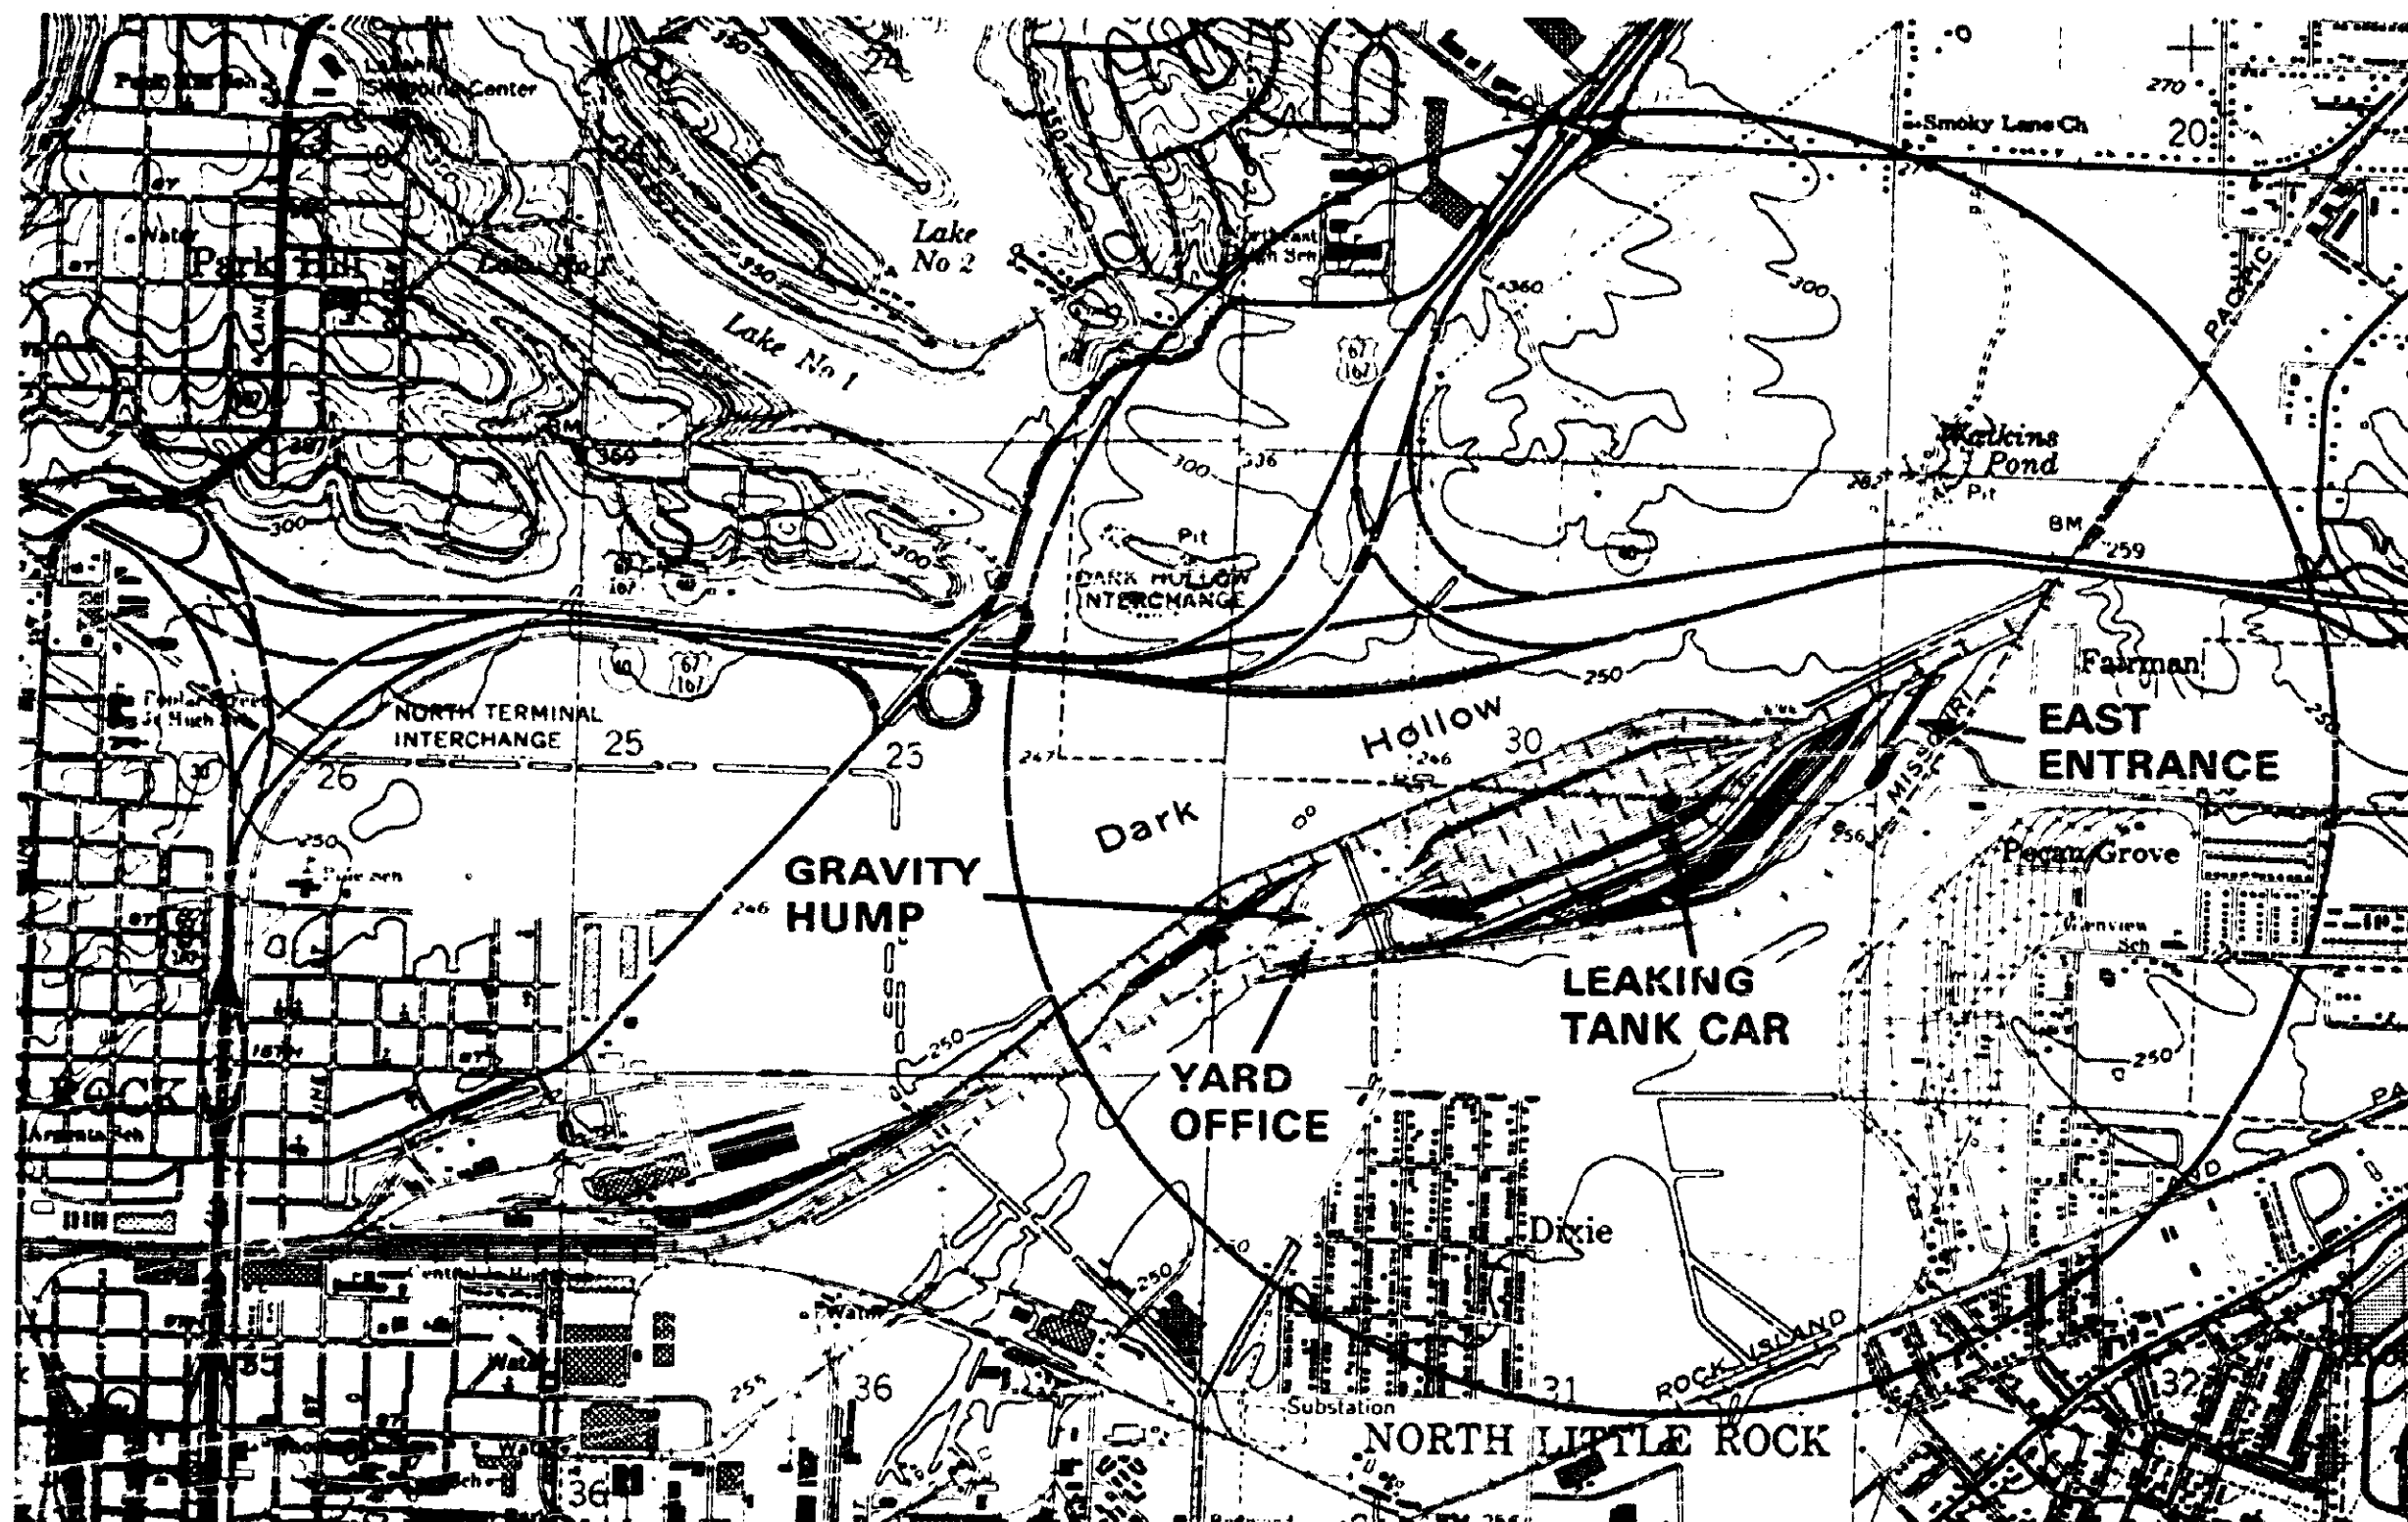
Figure 1.--Area evacuated around RAIX 7033.

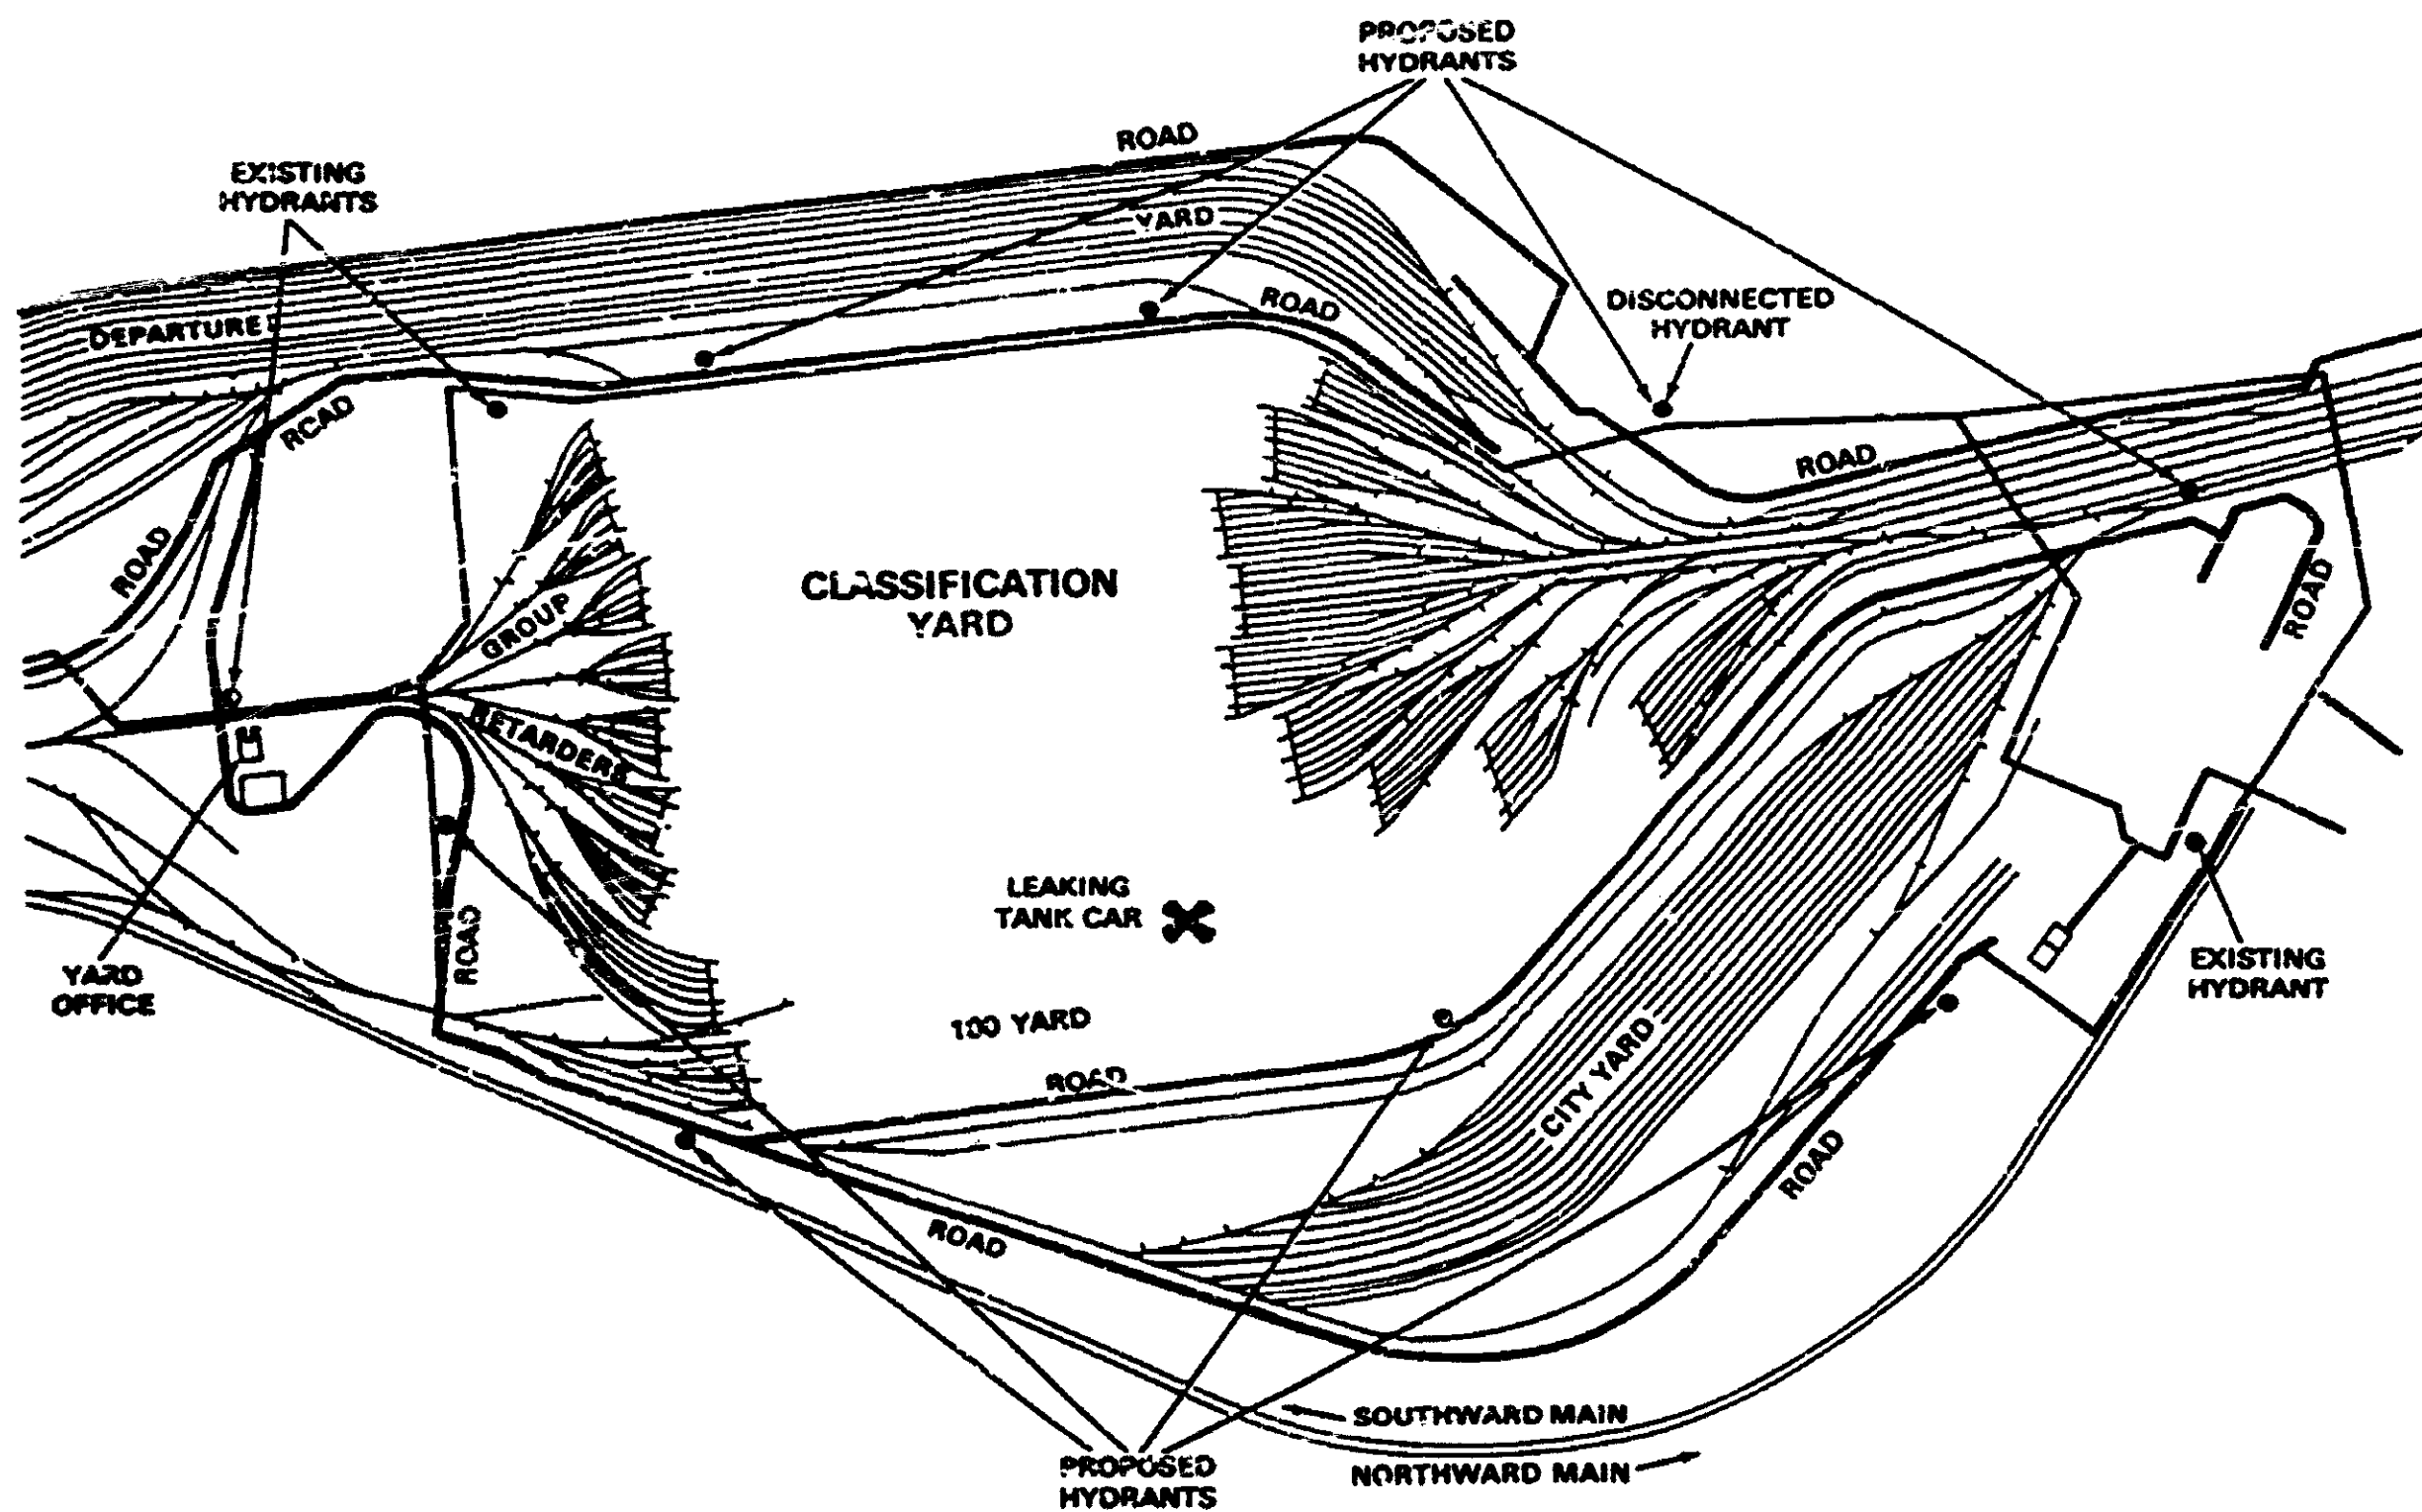
Figure 2.—Sketch of railroad yard showing tracks, fire water system, and access roads in relation to the leaking tank car.

Roads within the yard are located parallel to the northern-most classification track, and the southern-most track in the One Hundred Yard. A 4-inch steel fire water main with a fire hydrant is located across from the northern most classification track about 1,550 feet from the location of the leaking tank car. A fire hydrant is located

at the east entrance to the Yard near Bethany Road, and the estimated distance from the fire hydrant to the area of the leaking tank car is about 1,750 feet. A fire hydrant also is located near the yard office which is about 1,850 feet from the area of the leaking tank car. The distance between the two roads is approximately 1,400 feet.

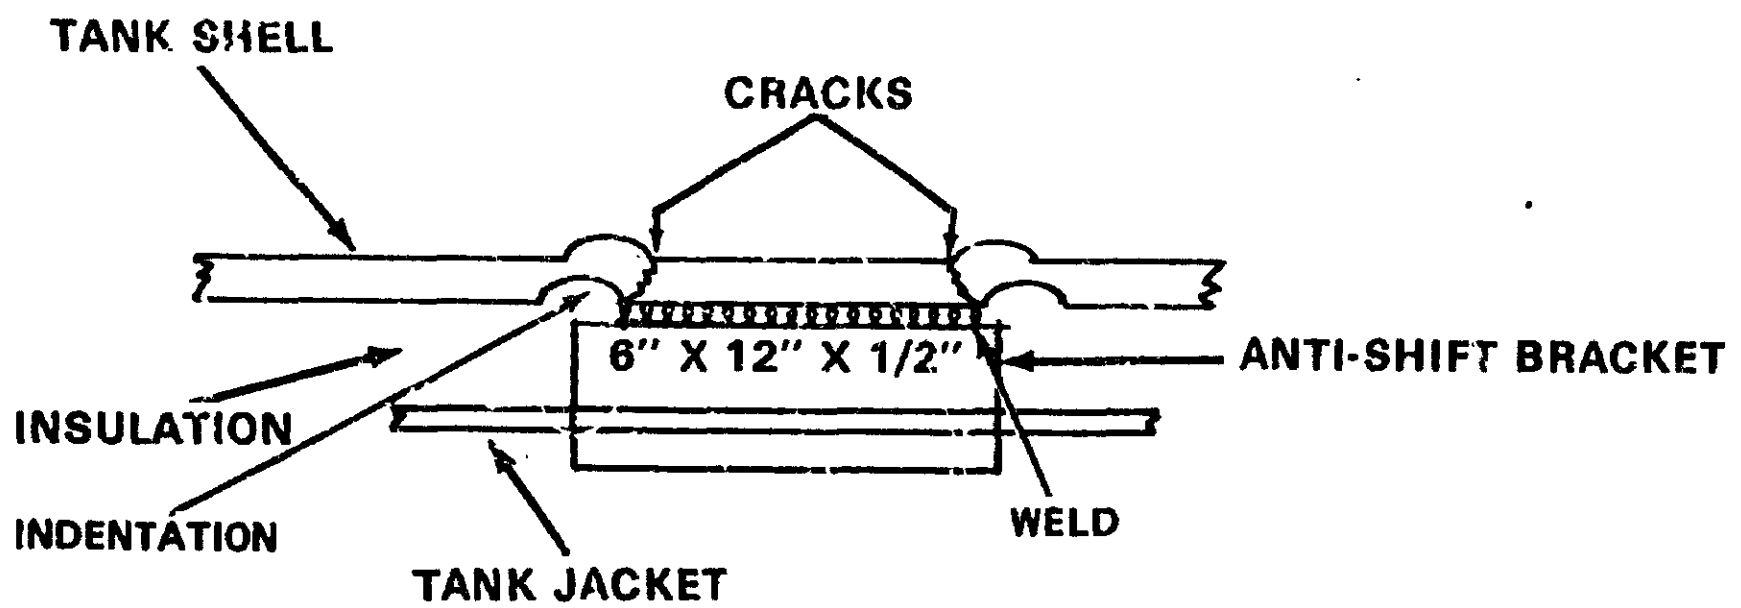
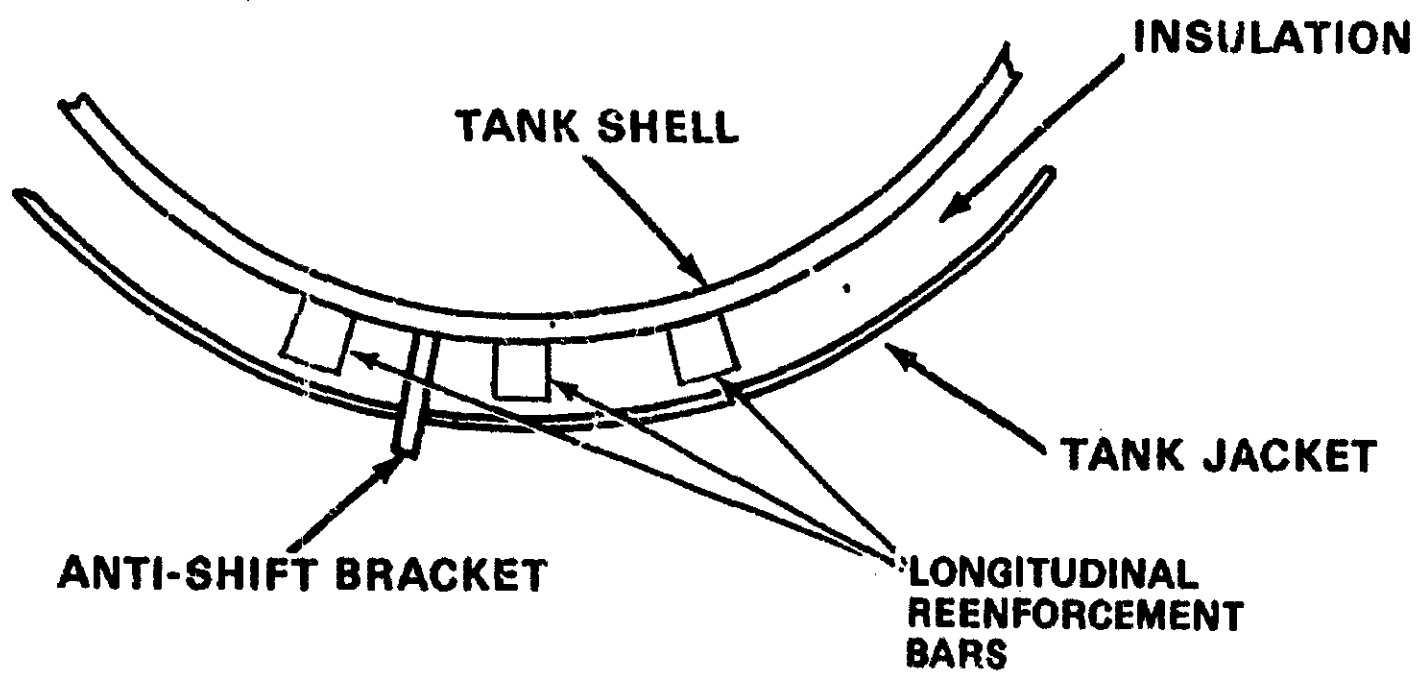
Figure 3.--Sketch of tank car sample area.

On January 2, the tank car was transported by rail to Carbide's plant at Taft, where it was flushed with water and drained. An internal visual inspection of the car revealed two through-wall cracks near the center of the bottom of the tank. The internal crack locations corresponded approximately to the extremities of the 9-inch-long welds attaching the anti-shift bracket to the tank shell. The cracks ranged from 2 1/2 to 3 3/4 inches long and were half-moon shaped.

Metallurgists from Carbide and the Safety Board removed a section of the tank shell for metallurgical examination. The section included two through-shell cracks, two indentations, a section of the tank shell bottom plate longitudinal reinforcing bar, the anti-shift bracket, and part of the jacket that was attached to the anti-shift bracket. (See figures 3 and 4.) The metallurgical examination was conducted by a metallurgical consultant in Houston, Texas, under the supervision of the Safety Board's metallurgist.
